# CMCE 44771 LAB; TX CRANE ACCIDENT

# CRANE ACCIDENT

Lab 01 – Report with recommendations - Austin Crane Accident

Quality Assurance CMCE 4471

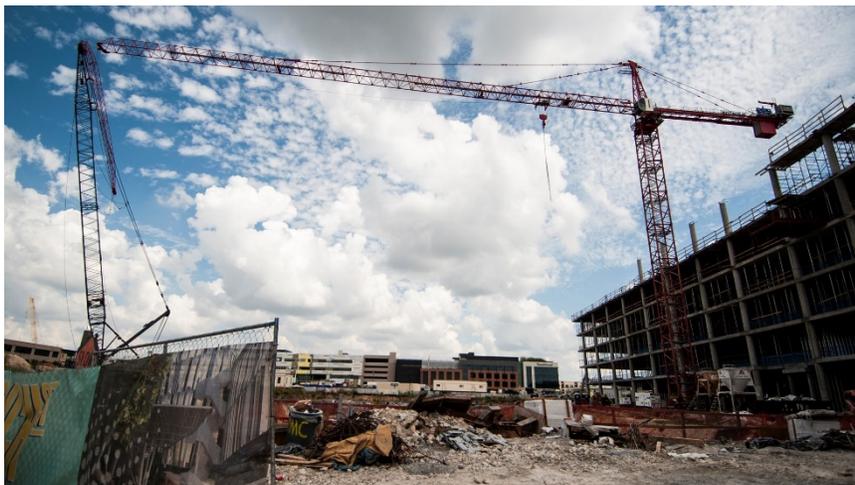
Figure 1: two cranes at a construction site. On the top of each crane they are both entangled with each other.

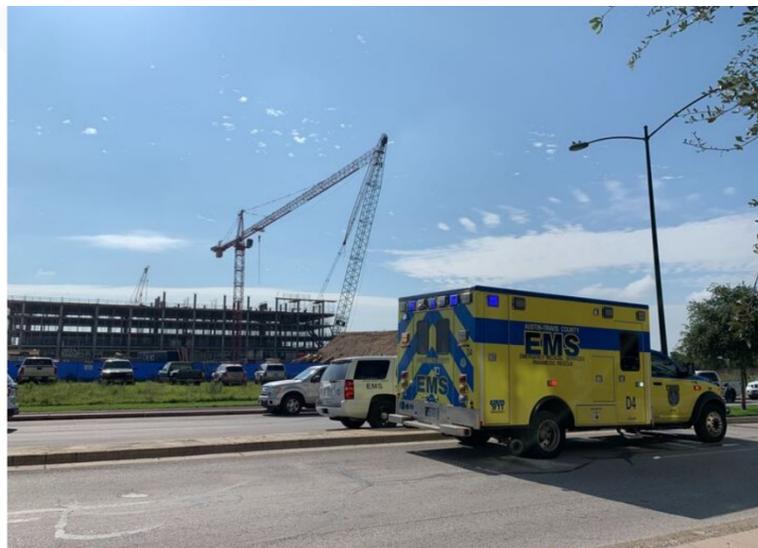
Figure 2 shows the EMS truck after the accident. In the background you see the parking lot structure and both cranes that are entangled with each other.

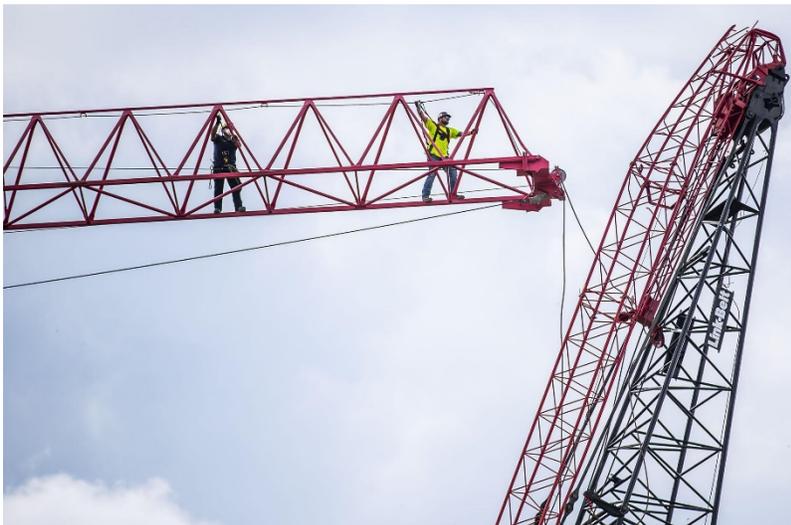
Figure 3: this shows the two cranes that are entangled with each other which is the black crane and the red crane. This shows a third convenience to help untangled the other two cranes and two workers.

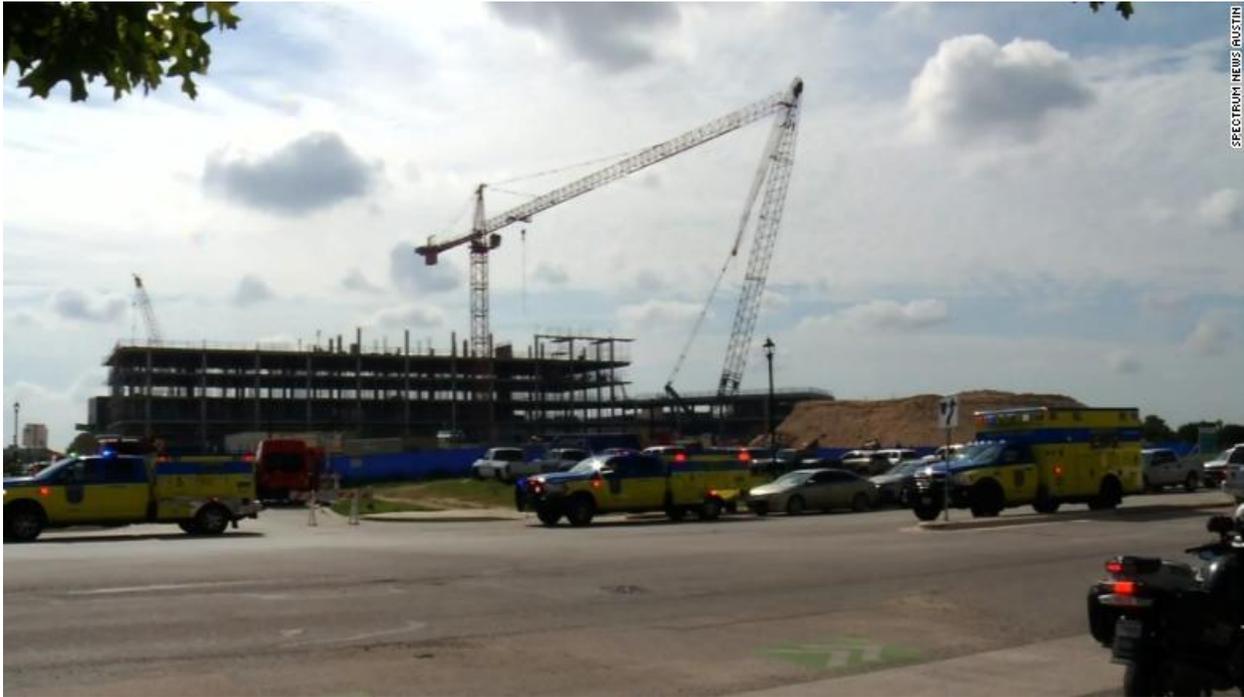
Image 1: Two cranes entangled on the jobsite. Source CNN

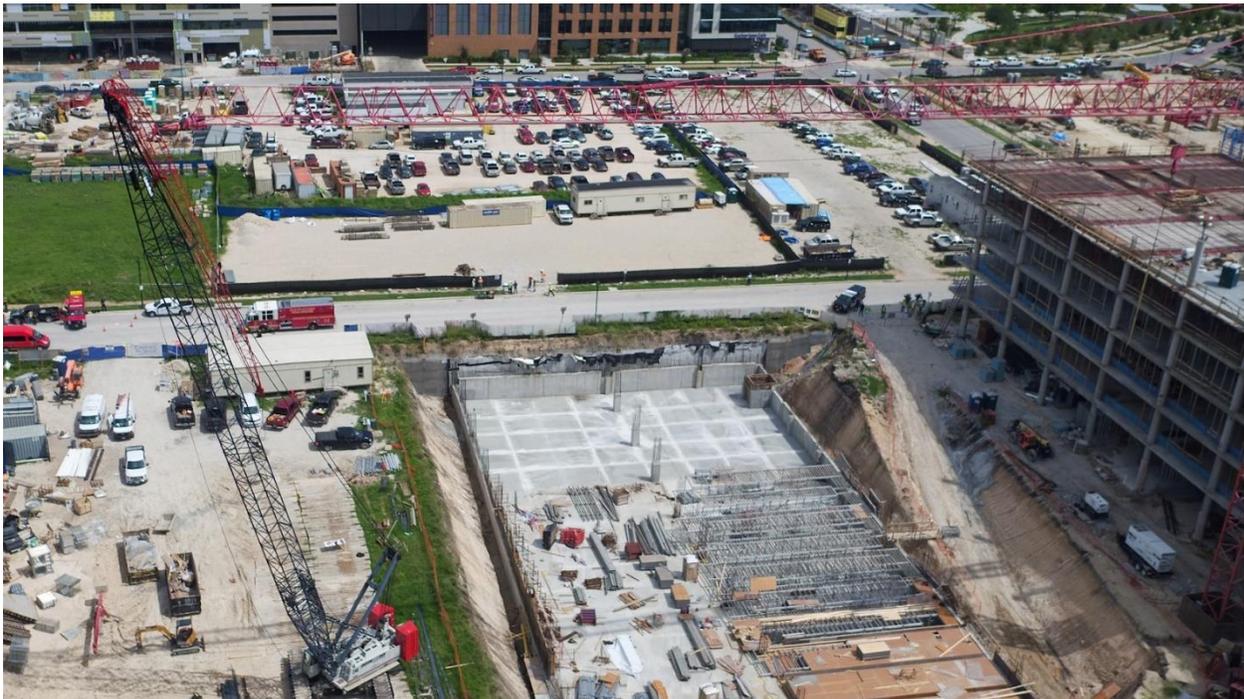
Image 3: aerial view of the two cranes entangled on their respective jobsites. Source: KVUE via wfaa

Based on the images it seems as if the tower crane swung around and hit the tip of the crawler crane. Both crane operators were not harmed, and the operator of the tower crane remained in the operator's

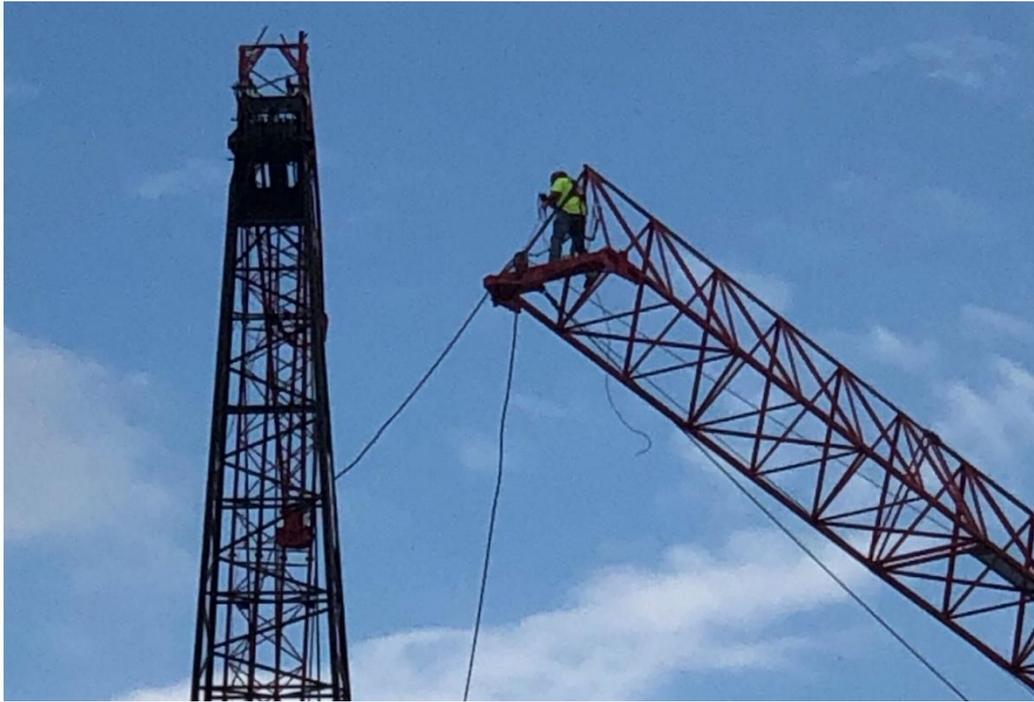
Image 4 worker trying to detangle cranes after the accident. Source: Scott Guest via wfaa

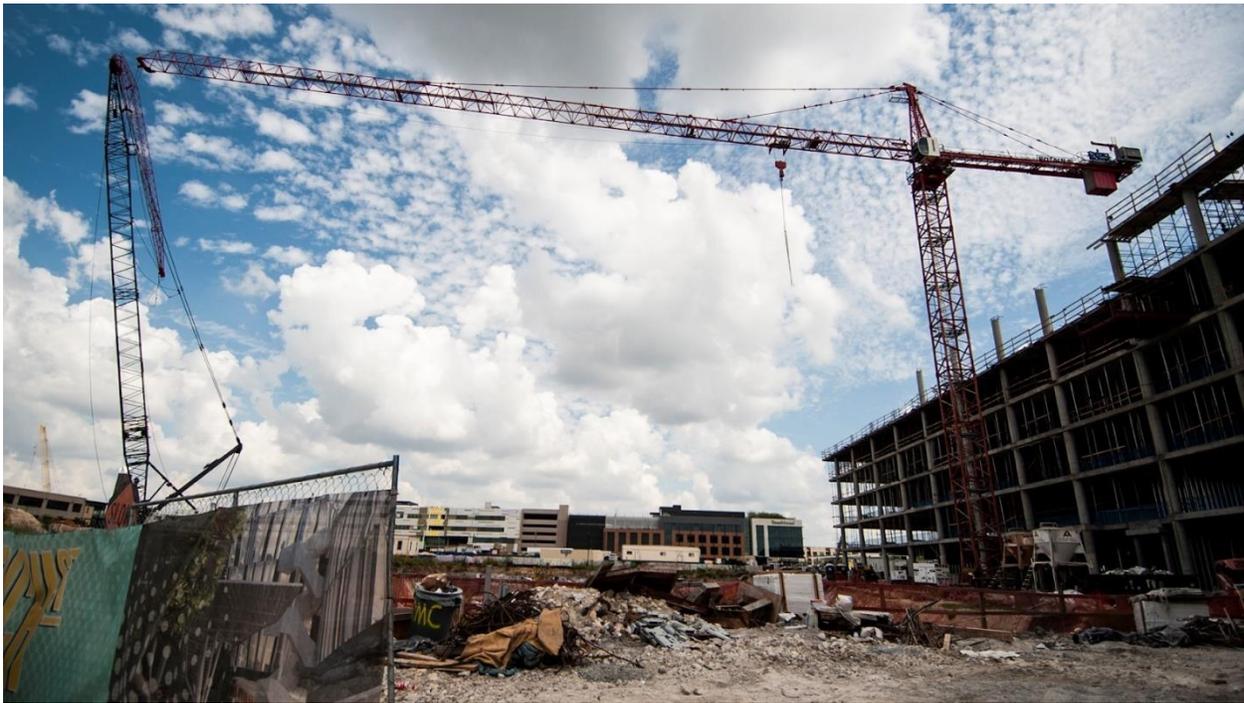
The last item which I believe to be a major cause of the subsequent injuries due to the accident was the jobsite condition and the lack of training each employee onsite had in terms of how to handle an emergency. All the injuries which occurred onsite were due to people fleeing the scene. This means that there was chaos on the ground and the workers who were trying to escape either did not know how to evacuate or they were unable to flee in a safe manner. Based on the photo below from local news footage, it seems as if there may have been some housekeeping issues onsite which prevented workers from escaping safely.

Image 5: one of the construction entrances at the accident location. Source: John Gusky via wfaa

In this image there is debris piled up in front of the entrance gate which is most likely an evacuation route for emergencies. If the workers who were fleeing were unable to climb over this pile of trash, they most likely were funneled into an area too small for proper evacuation and were trampled. Another scenario is that workers were injured while attempting to climb over this pile to escape the jobsite. Poor housekeeping on the jobsite falls on the shoulders of the project managers and superintendents. No matter whose responsibility it was, someone from any team that has knowledge in jobsite safety should have reported this issue. If reported, there may have been significantly less or even no injuries due to this crane accident.

- Having the superintendent, general contractor, and subcontractor do regular safety checks and walk through of the jobsite. By doing so they can address issues like housekeeping or any other safety issue which is observed, and notice that these two cranes were too close and could collide. If there was more attention paid by the field management teams, this incident could have been avoided.
