# COMMERCIAL CONSTRUCTION SITE OBSERVATIONS AND ANALYSIS

RESEARCHERS: VICTOR, SAMIT, & LANGSTON

LOCATION: JAY ST, APPROX. 300 FT  
SOUTH EAST OF THE VOORHEES  
BUILDING.

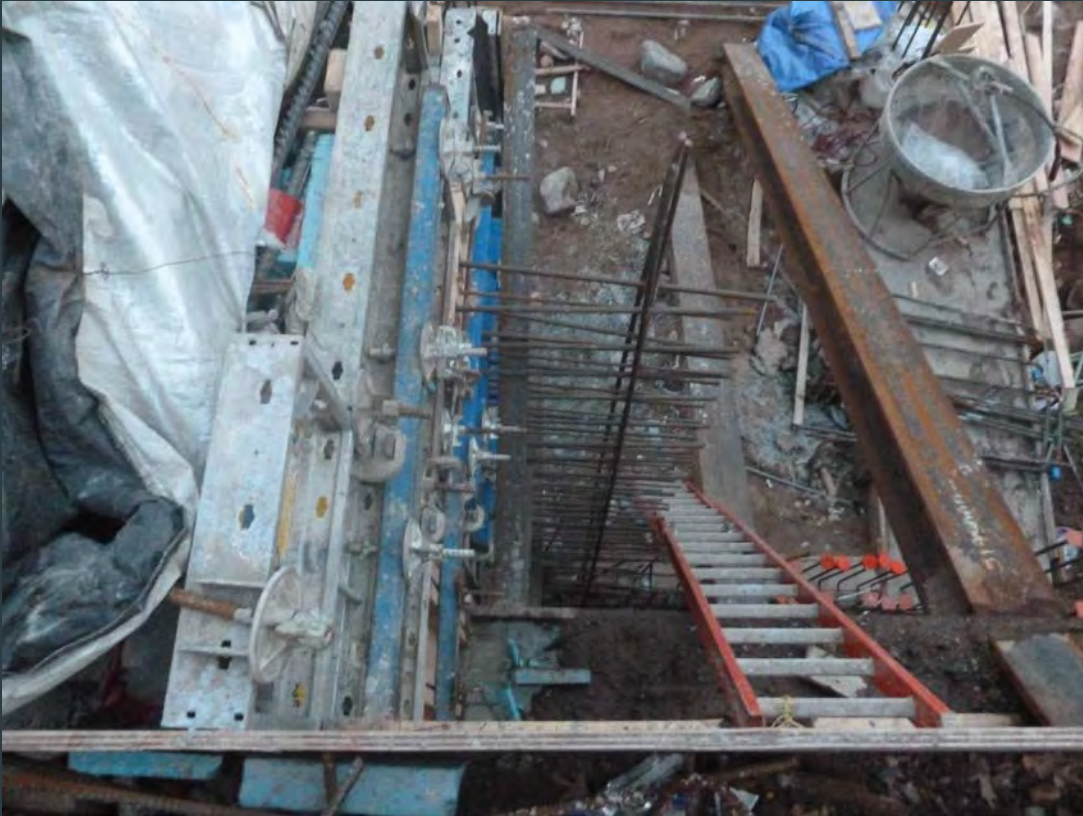
As you can see, there are horizontal rebar's extruding from a structure that seems to be braced with metal beams.

-Ok, so I have no idea why the rebar is horizontal. To help accommodate compressive stresses to the wall is the only thought that comes to mind

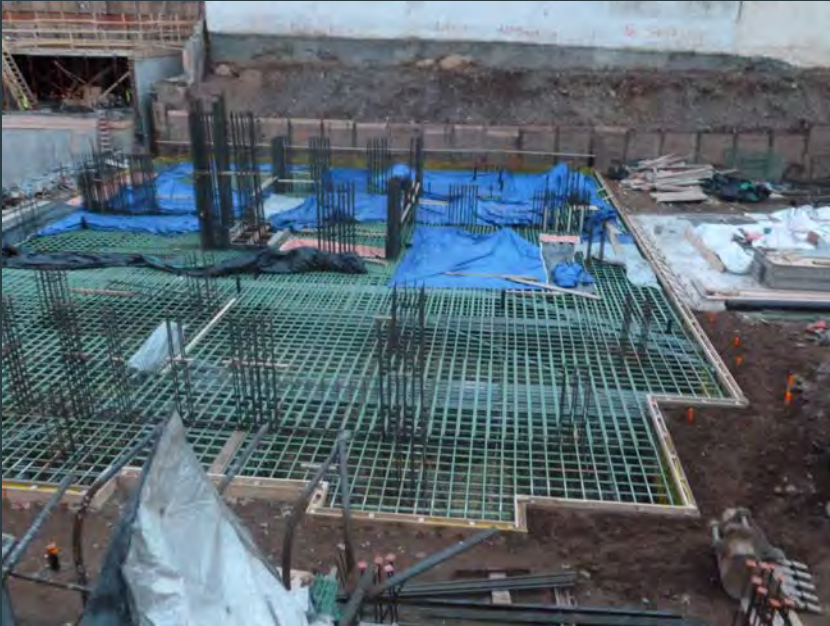
This looks like coated/treated rebar that will soon be set into poured concrete. The vertical rebar is untreated and will probably end up being columns or walls that will support the structure

- How deep is the space under the rebar grid?
- Do these vertically placed rebar represent the locations of walls/rooms/cloumns/partitions?

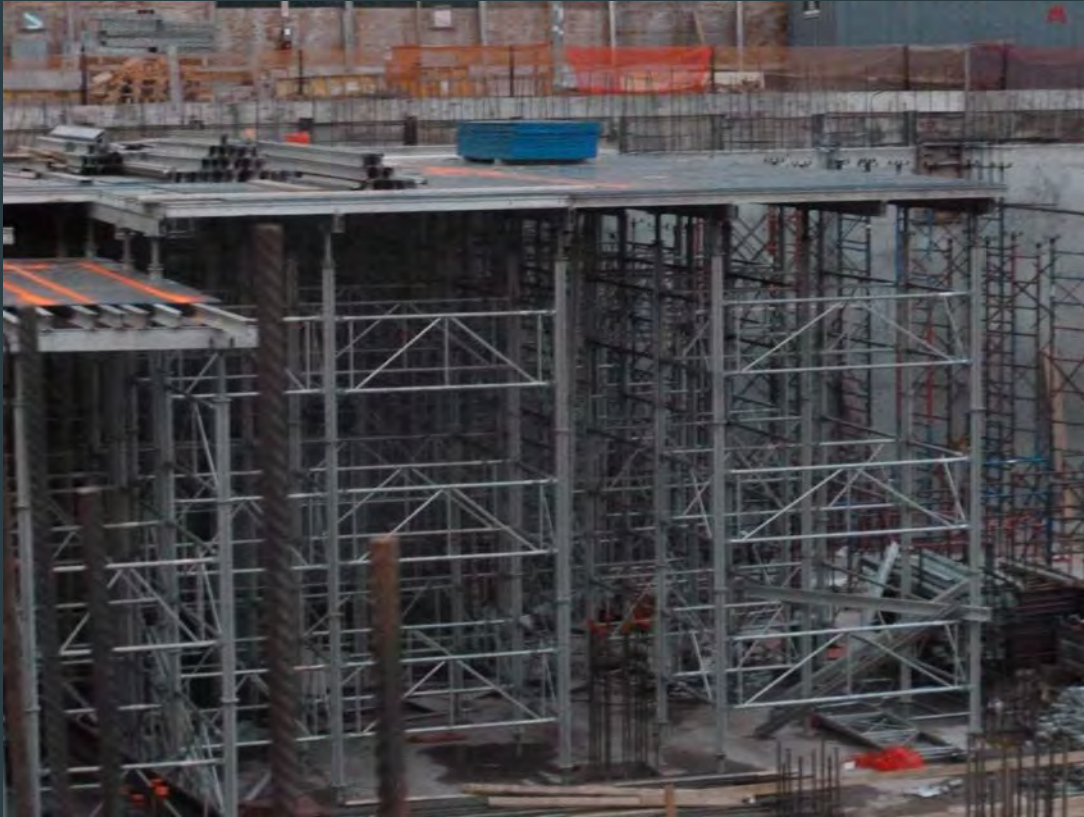
Judging by the patterns of this metal skeleton, it is acting as bracing and distributing loads

This space does not look accessible, except for the middle section. So, it's probably a foundation that sits above ground level.

-Looks like the top flat surface is in cohesion with the street level

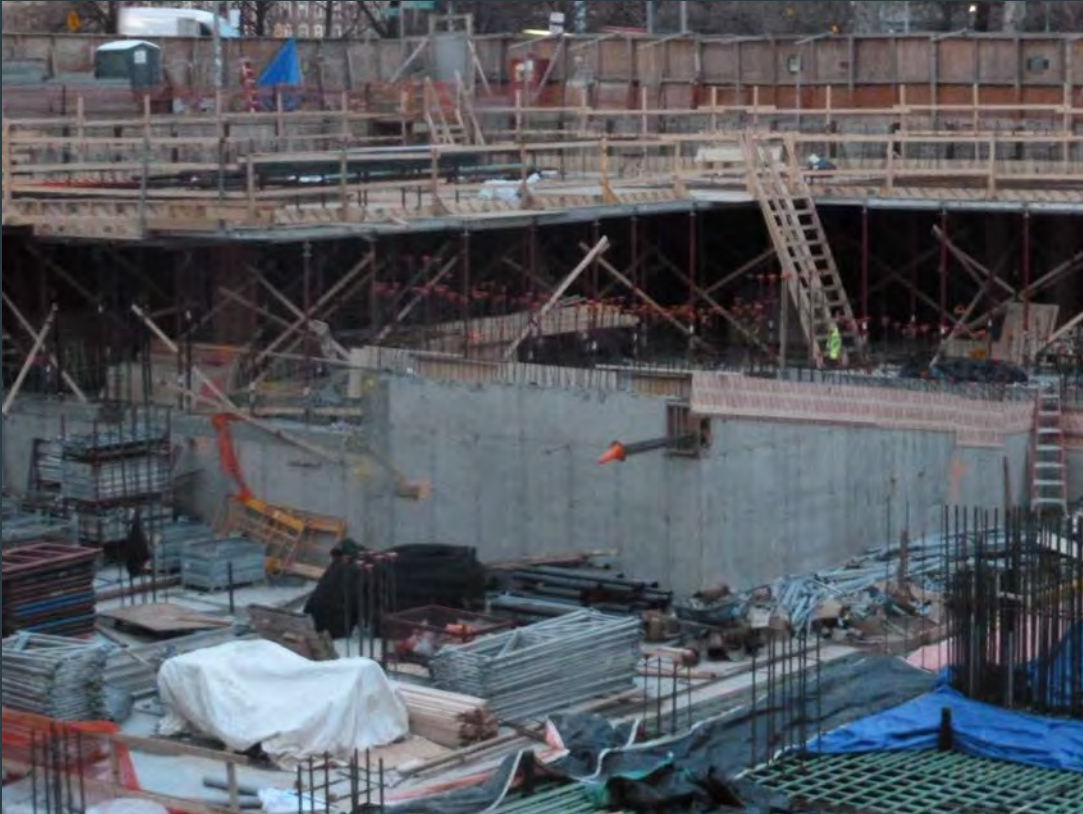
Materials are organized. Which is crucial to optimum productivity on site

Cross bracing above foundation wall and guard rails for safety purposes

Pipe extruding from wall is probably for plumbing purposes
