ASSIGNMENT_0

CIVI SITE ANALYSIS

LOCATION: 543 MAIN ST, NEW YORK, NY 10044
 ZONNING DIVISION: R7-2,C4-5 R= RESIDENT C= COMMERCIAL

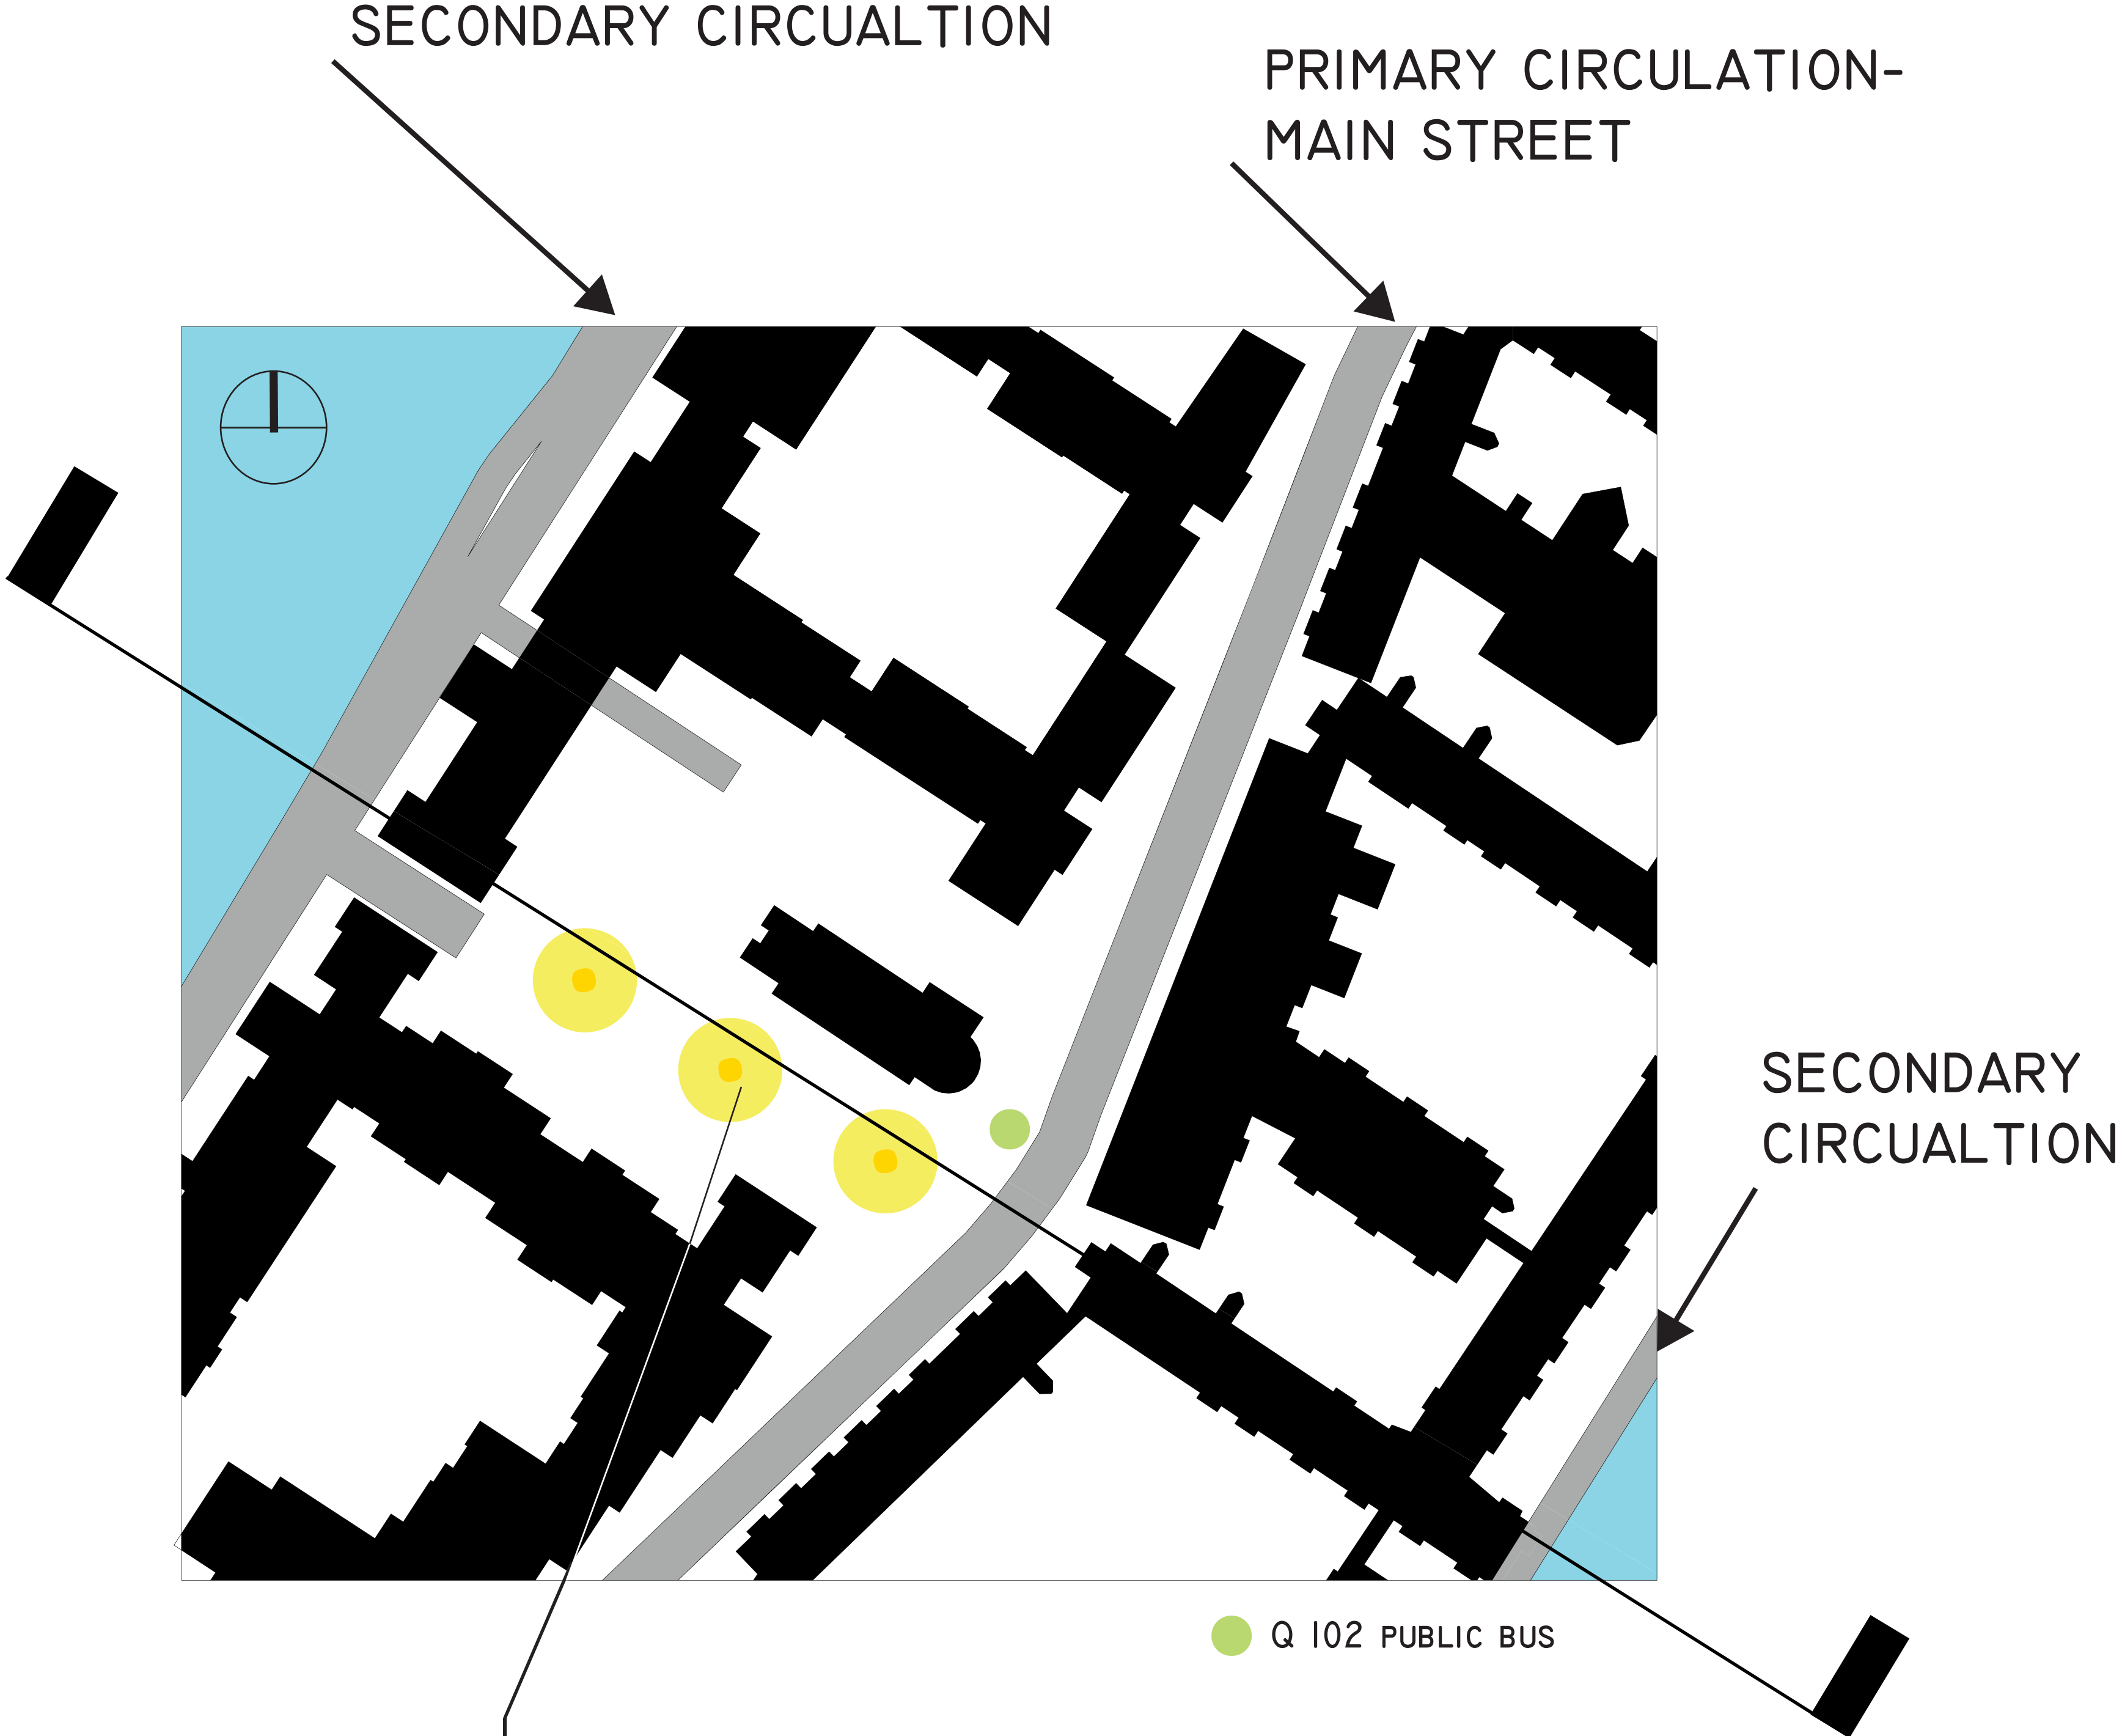
LIGHTING IS POORLY DISTRIBUTED. THREE LAMP POST DUE TO HISTORICAL VAULE UNDERMINE THE SPACE'S NEED TO BE MORE WELL LIGHT. SPACE IS INEFFECTIVE AFTER SUNSET.

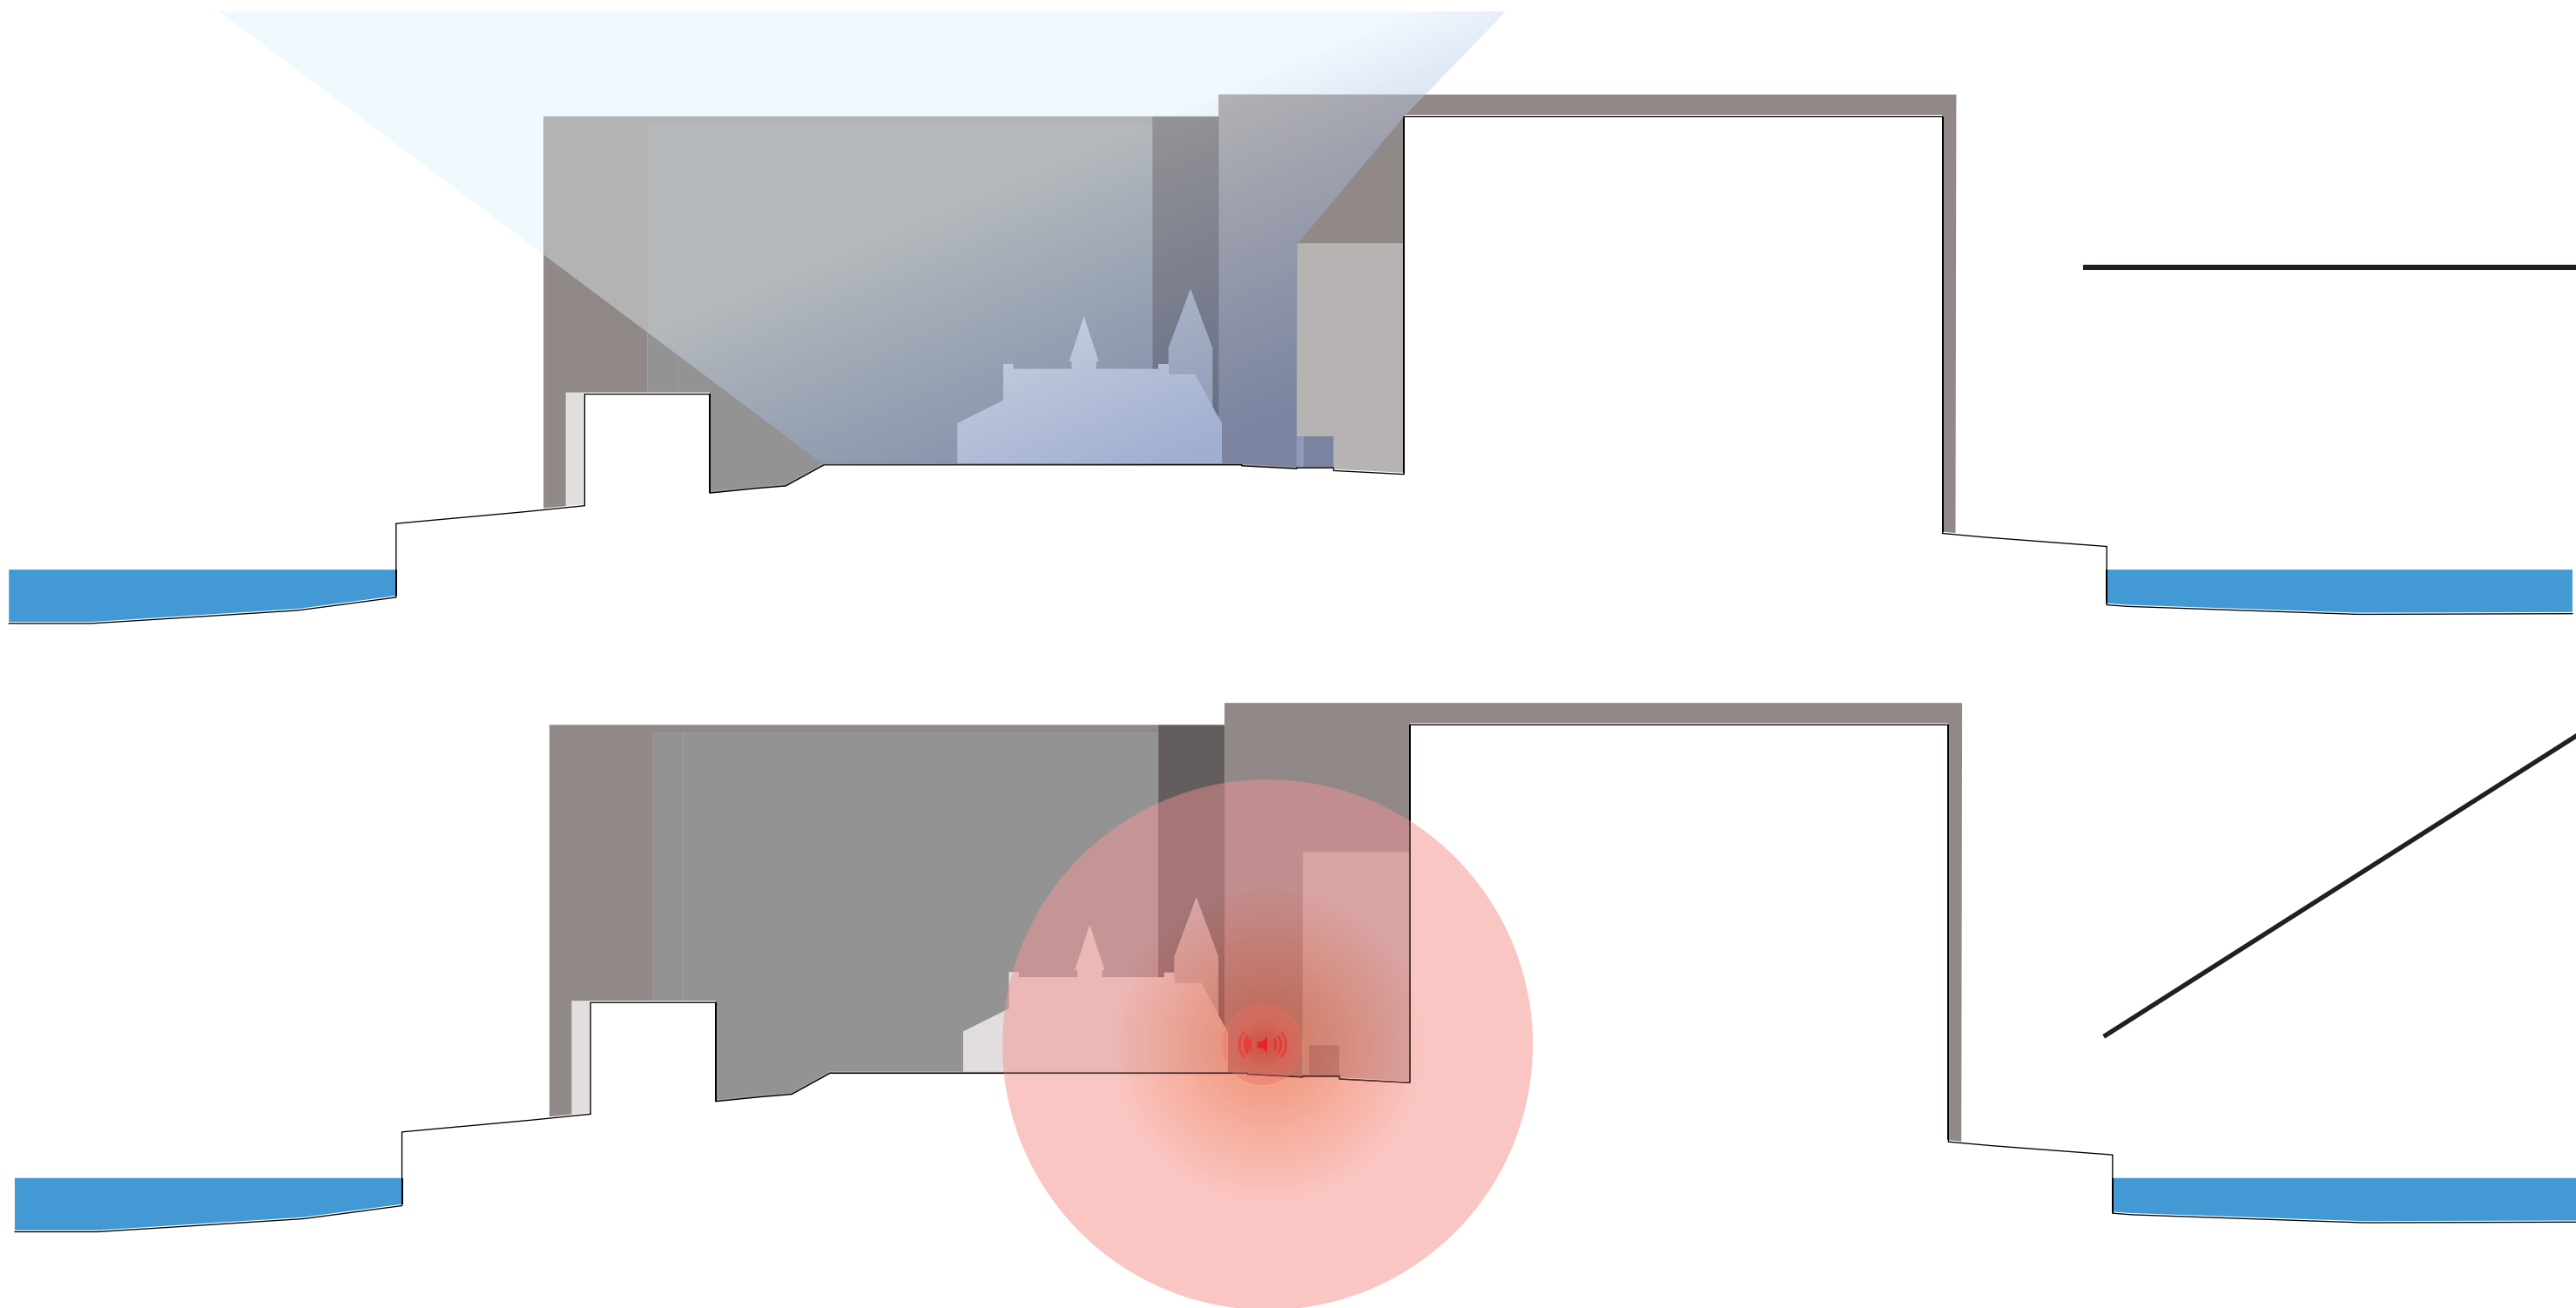
OPEN SKYVIEW OVERHEAD MAKES THE SPACE FEEL MUCH BIGGER THAN IT IS.

MAIN STREET IS A SOURCE OF AUDIO DISTURBANCE SINCE THERE IS NO NATURAL ACCOUSTICAL INSULATION DUE TO THE OPEN SPACE AROUND THE CRHURCH.
