Learning Places Spring 2016

SITE REPORT

Site Visit # 3, Vinegar Hill

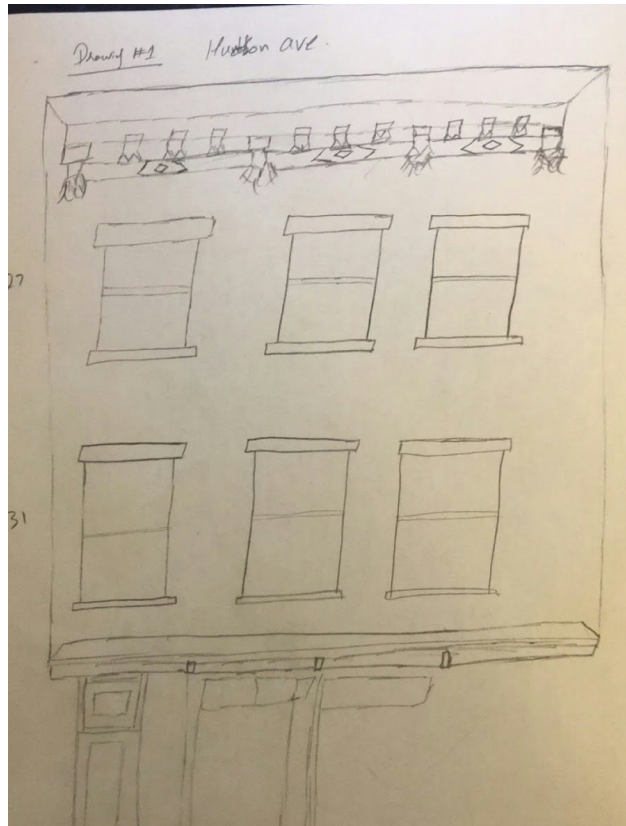
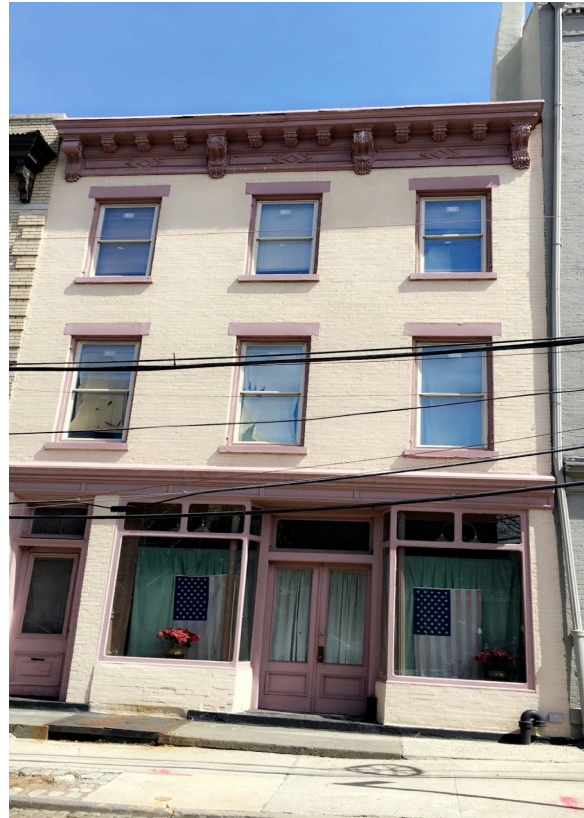
This is a rough sketch of the third building on Hudson Ave, meanwhile while we were sketching this building our prof was telling us details of this building. One of the architectural details that separated this building from most of the other buildings in Vinegar Hill is the cornice. Unlike the simple cornices that can be found throughout the neighborhood, this one is much more ornate. This cornice is wide with brackets. It also appears to have more of a curvy shape than a Greek Revival cornice would. As you can see on the left of this sketch some numbers I wrote these numbers mean rows of bricks in each section of upper three windows and lower three windows. If it's hard to tell the difference in the height of the windows, instead of measuring with a measuring tape we can just count how many brick rows are there, it will tell us the height of the

window. In our case lower windows are larger than upper windows, because lower windows have 31 rows of bricks on the other hand upper one have 27 rows. On the right side is the original photo of the upper sketch, In which you can see the building had painted over the entire front of the structure. The top is a wooden detail but has since been painted a pink color. The stone lintels, wooden doors, and metal work of the window frames is the same shade of pink. The brickwork has also been painted with cream color, Under the paint, if you see little closer you will see that the bricks are a running with bond pattern. The running bond brickwork and the paint of the building clearly tell us that building had some renovations done.

3. Age of Buildings (provide evidence for prediction)
 - a. The first building that we sketched on Hudson Avenue was probably one of the original mid 19th Century buildings.

5. Building Details
 - a. A mid 19th Century brick building would have a bond pattern, but the buildings had a running bond, The brickwork on all three buildings had been redone at some point probably in the 20th Century.

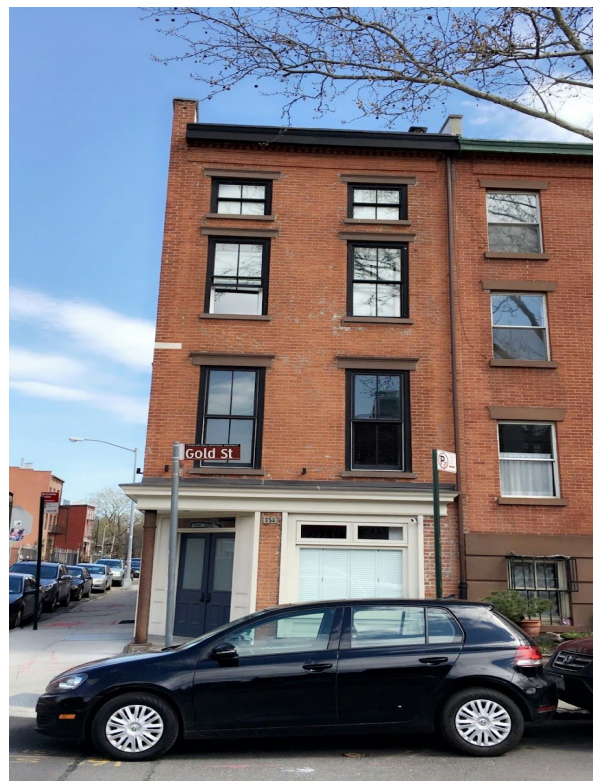
Photo on the left is sketch of the second building which was on the corner of water street and Gold street. As you can see this building is combination of both residential and commercial. This building was also built in 19th century but by looking at this building today i could tell i had some modern touches on it, for example windows, glass and security cameras. One thing you can notice in this building very clearly is the different size of all floor windows, looks like first 3rd floor is not an actual residential floor it looks more like storage room because windows are really

small. The brickwork has been redone to showcase a running bond pattern.

- b. The second building that we sketched that was on the corner of Water Street and Gold Street is most likely one of the original mid 19th Century buildings.

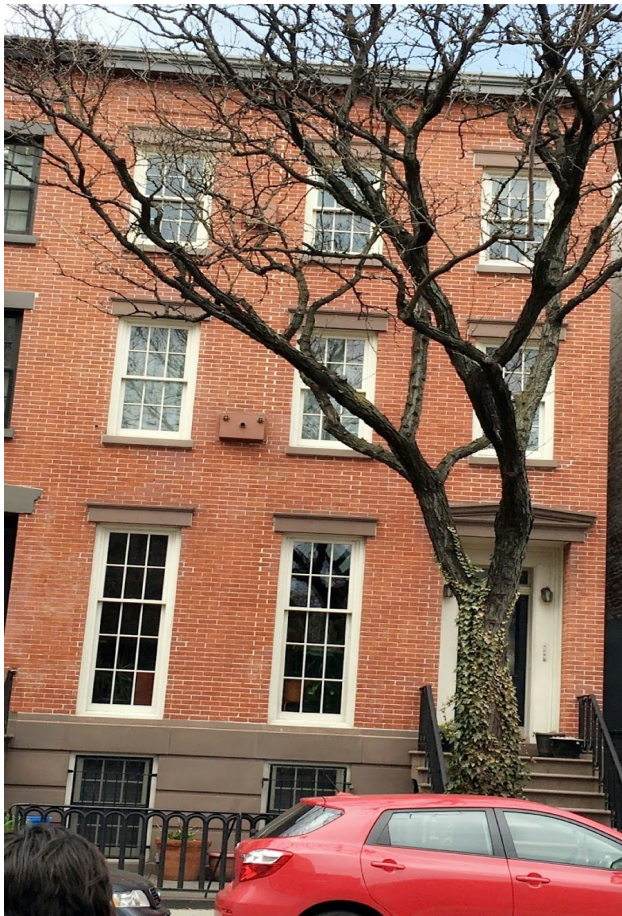
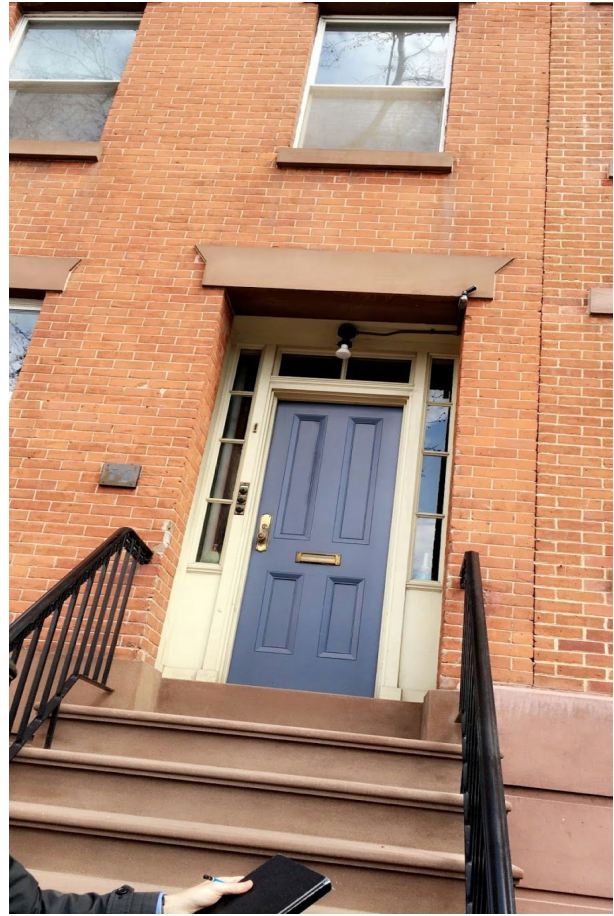
These both photos are taken on the front street almost in the middle of the block. This house is the most modern looking building at off all three buildings we looked so far. The windows and doors are really fancy looking, feels like residents of this house are pretty wealthy. If you look closely at the windows of the building on the left you will see all windows in this building are different sizes as well like other two buildings. Secondly it looks like amount of rectangles in these are almost same, but actually they are not same. Top two floor have 12 rectangles in the windows and window have divider in the middle but the last window on 1st floor have 15 rectangle that's why the divider is not in the middle, i couldn't see this detail until i really focused. Photo on right side is door of another building which was really next to it. The lintels of the first photograph are simpler than the second building, The design of the lintels is not Greek Revival. The lintels above the door in the right photo is Greek

Revival. This is made out of stone.

- b. The third building, on the front street which was only residential, had a stoop of nine steps leading up to the front door. This building also had some sort of boxes on front seems like some sort of ventilation systems.
