Learning Places Spring 2016

SITE REPORT

Vinegar Hill, Revisited

Gerard Jitechian

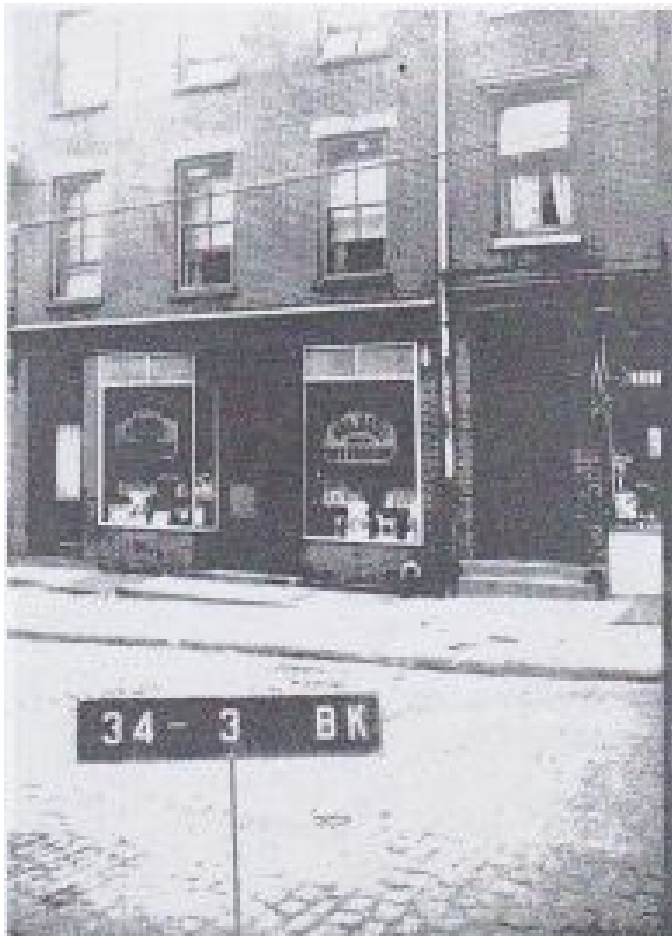
1930's tax photo

My curiosity about the original use of the building lead me to visit the NYC Municipal Archives at 31 Chambers St. in Manhattan. I was able to use the microfilms of the 1930's tax photos to find a photo of the building. The photo shows the storefront, residential door entrance and window lintels have remained relatively intact, albeit some cosmetic changes. The 1930's photos shows the bottom store was a Bar, Grill and Restaurant with small horse statues displayed in the large windows bays. According this photo, the neighboring building, at 53 Hudson Avenue, which also had retail space on the ground floor was only a two story building, but is currently a three story building.

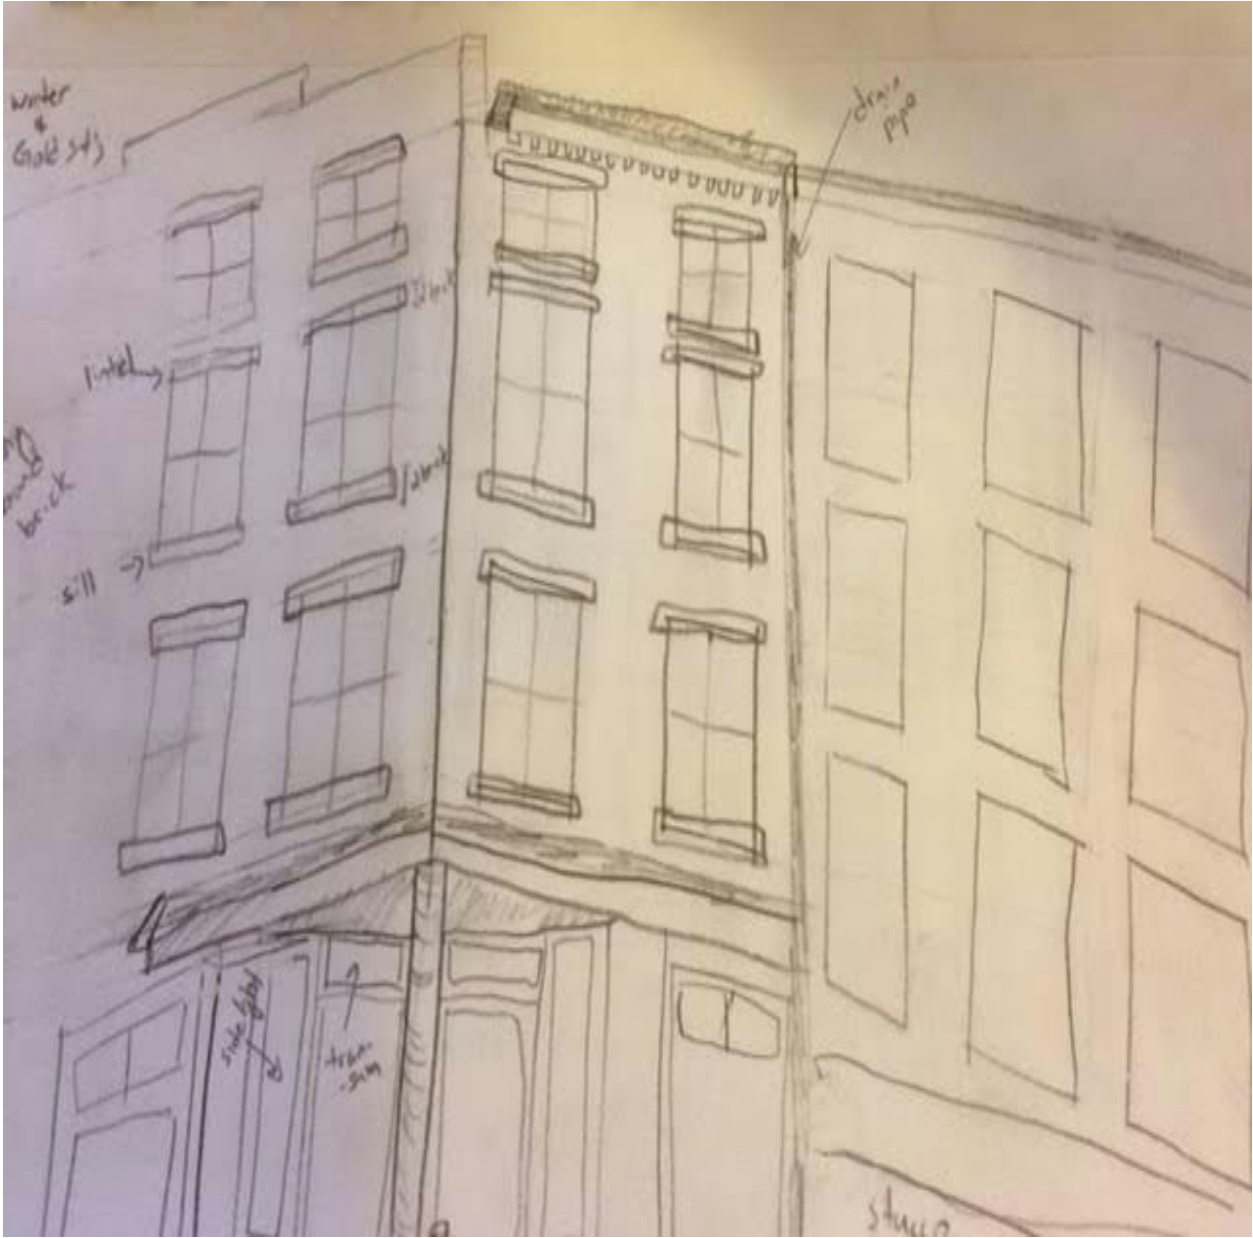
Building 2 Sketch: 69 Gold Street

The building at 69 Gold Street which is at the corner of Gold Street and Water street falls on the North East boundary line of Area II of the historical district designated by LPC in 1997. This is a four story brick building was built in the 1840's and has a rear addition with wooden garage doors. The cast iron center column, focus on the double door entrance can be considered elements of Greek Revival architecture. Similar to 49 Hudson Avenue, the ground floor entrance of this building, suggests it served as a retail or restaurant space. According to the LPC designation report, the building at 69 Gold Street was a liquor store in the 1970's owned by Michael O' Connor. The 1930's tax photos from the Municipal Archives confirm that in the mid 1900's, the ground floor of 69 Gold Street was still a liquor store.

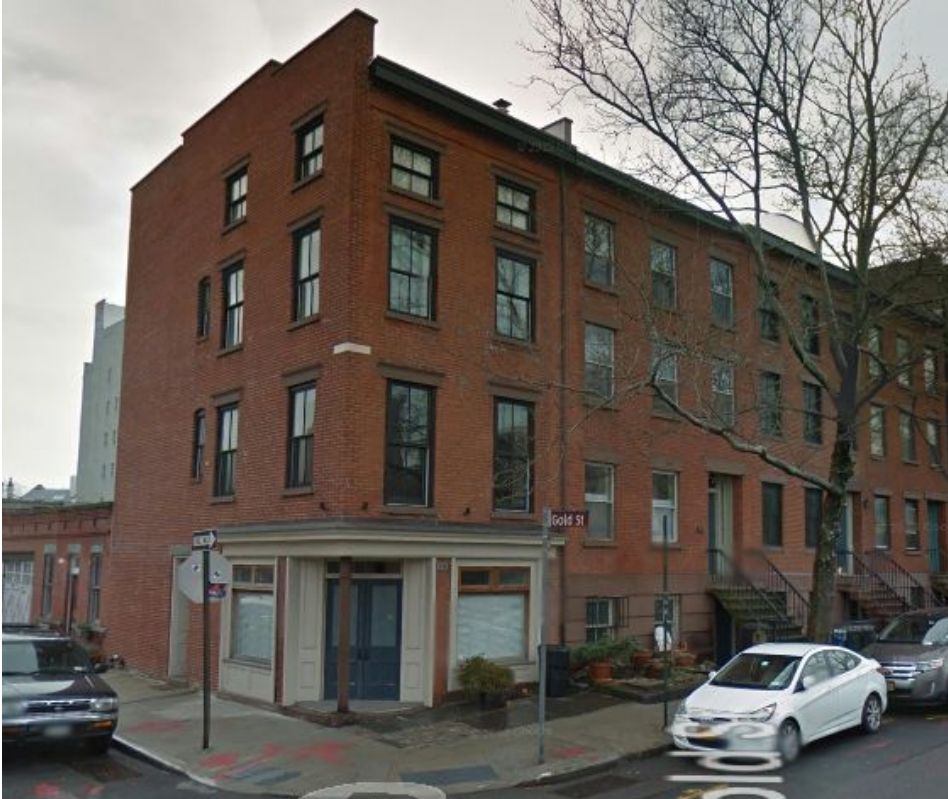
Building 2 Photo: 69 Gold Street

During our site visit, I noticed this building had been recently maintained and upgraded as a high end residential building. According to a September 26, 2014 Daily News article titled *'Vinegar Hill gets sweeter: DUMBO'S quiet neighbor may be headed for a real estate boom'*, the building was fully renovated with a roof terrace and full gym basement. It seems the recent developer wanted to attract the same recent high end residential clients that are now common to DUMBO, just a few blocks away. There are some differences between DUMBO and Vinegar Hill:

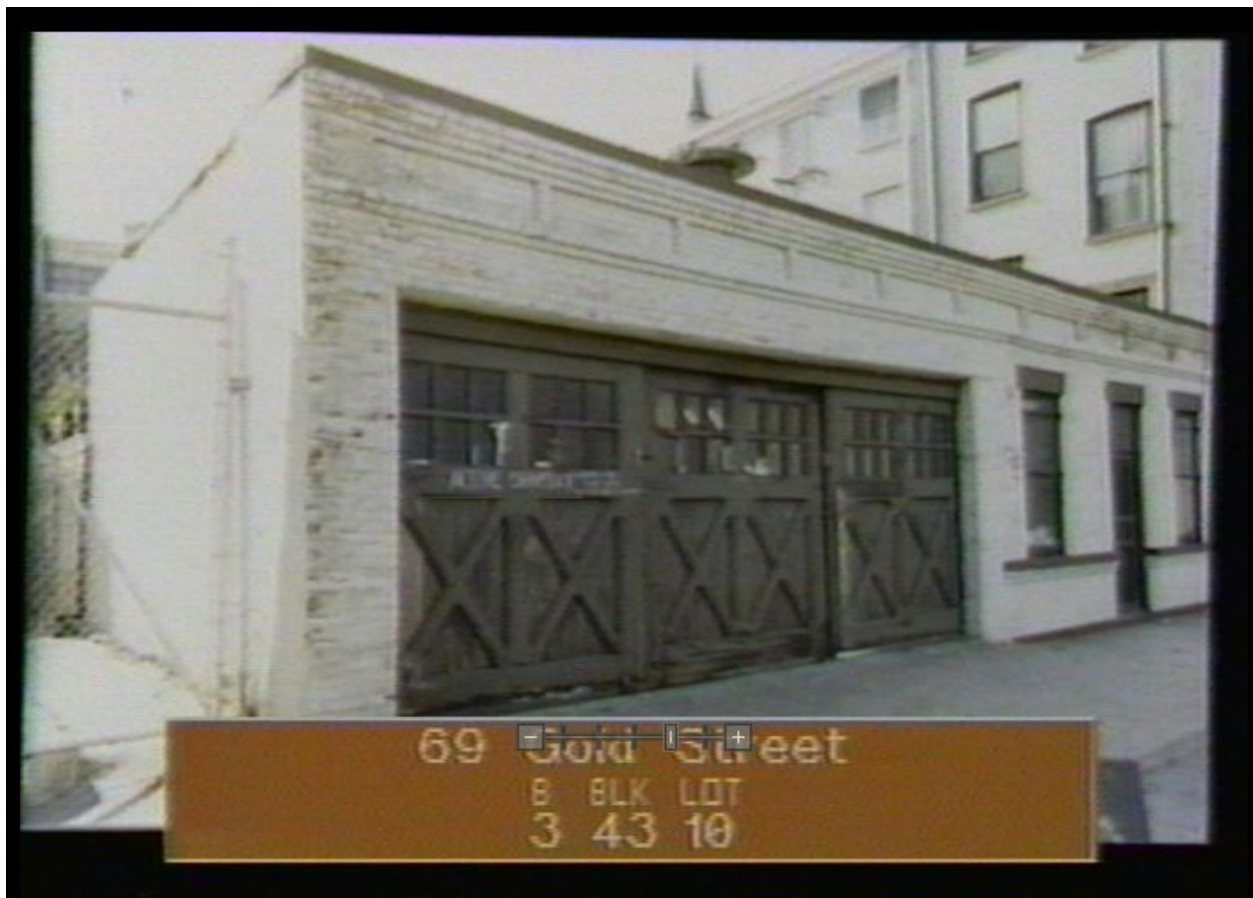
This is a 1980s tax photo of 69 Gold St., however it is a vantage from Water St. The rightmost taller structure is the back side of the images displayed prior. The garage structure seen is present in every photo since 1930. Note that the building has been painted brick red since.

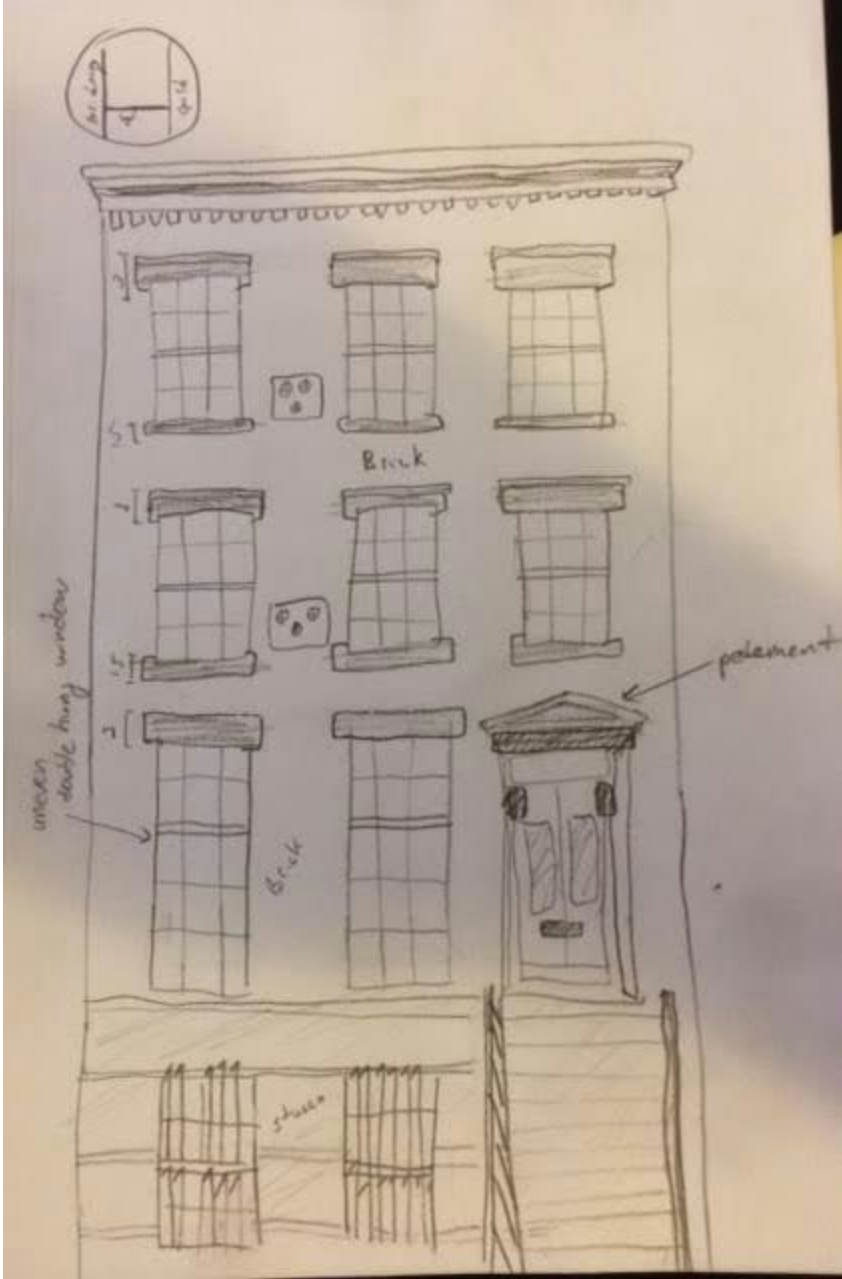
Building 3 Sketch: 239 Front Street

The building at 239 Front Street which is located between Bridge Street and Gold Street falls in Area I of the historical district designated by LPC in 1997. This structure has undergone changes since the 1980s. Most apparently, the brickface has been sanded down (or repainted) to a red-brick color. The cornice of the building seems to have been repainted as well, however its construction remains the same. The same applies for the window lintels and sills. The front door pediment seems to have been replaced or refurbished; the modern day pediment is more ornate, with a three dimensional extrusions, whereas the 1980 photo shows a flush, capitol pediment.
