# CMCE 44771 LAB; TX CRANE ACCIDENT

# CRANE ACCIDENT

Lab 01 – Report with recommendations - Austin Crane Accident

Quality Assurance CMCE 4471

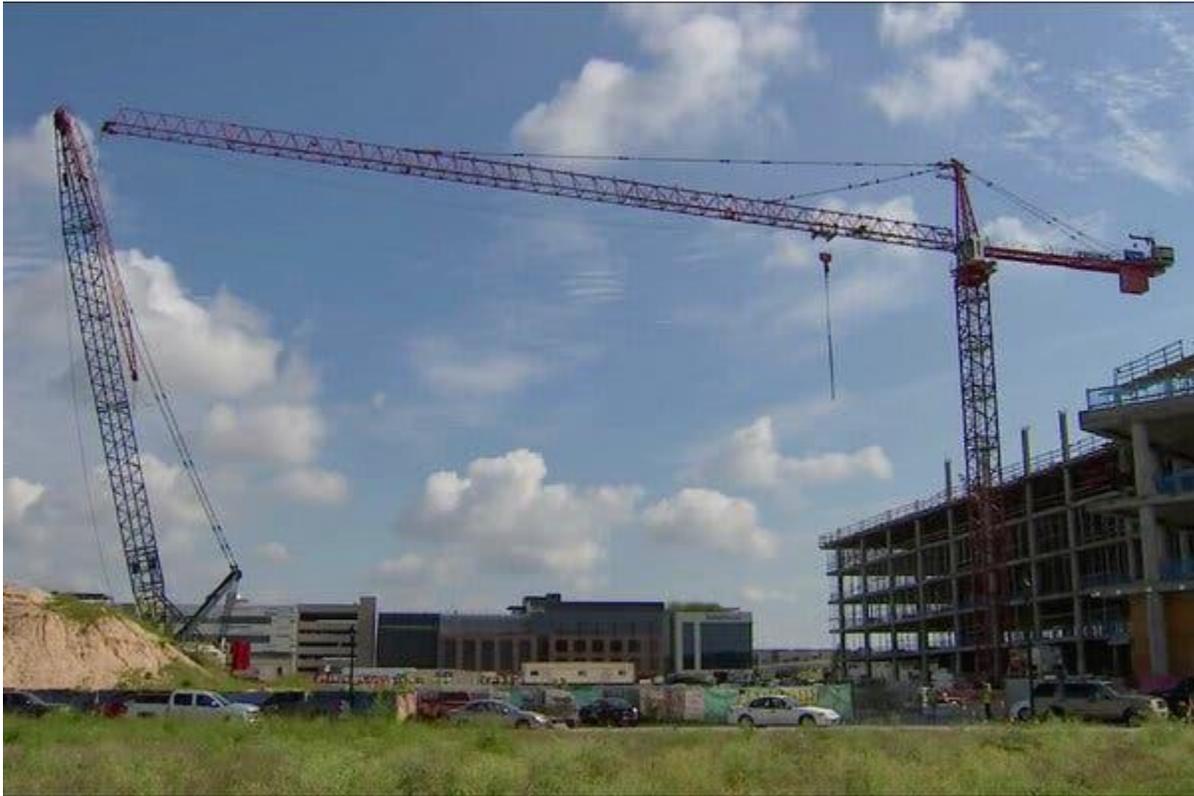
Source: Fox 7 Austin via Facebook live via new york times

As this is still an open investigation, some of the details as to what occurred are still unclear. However, from local news reports and photos we are able to understand the following; A tower crane working on erecting a structure adjacent to an underground garage also being constructed, became entangled with a large crawler crane that was working on the foundation of the new garage structure, see image below.
