# COMMERCIAL CONSTRUCTION SITE OBSERVATIONS AND ANALYSIS

RESEARCHERS: VICTOR, SAMIT, & LANGSTON

LOCATION: JAY ST, APPROX. 300 FT  
SOUTH EAST OF THE VOORHEES  
BUILDING.

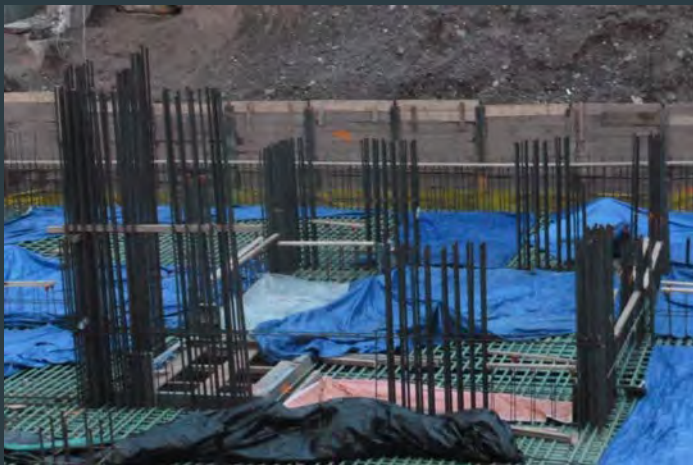
This looks like coated/treated rebar that will soon be set into poured concrete. The vertical rebar is untreated and will probably end up being columns or walls that will support the structure

- How deep is the space under the rebar grid?
- Do these vertically placed rebar represent the locations of walls/rooms/cloumns/partitions?
