Learning Places Spring 2016

SITE REPORT

Field Visit: #1 Vinegar Hill

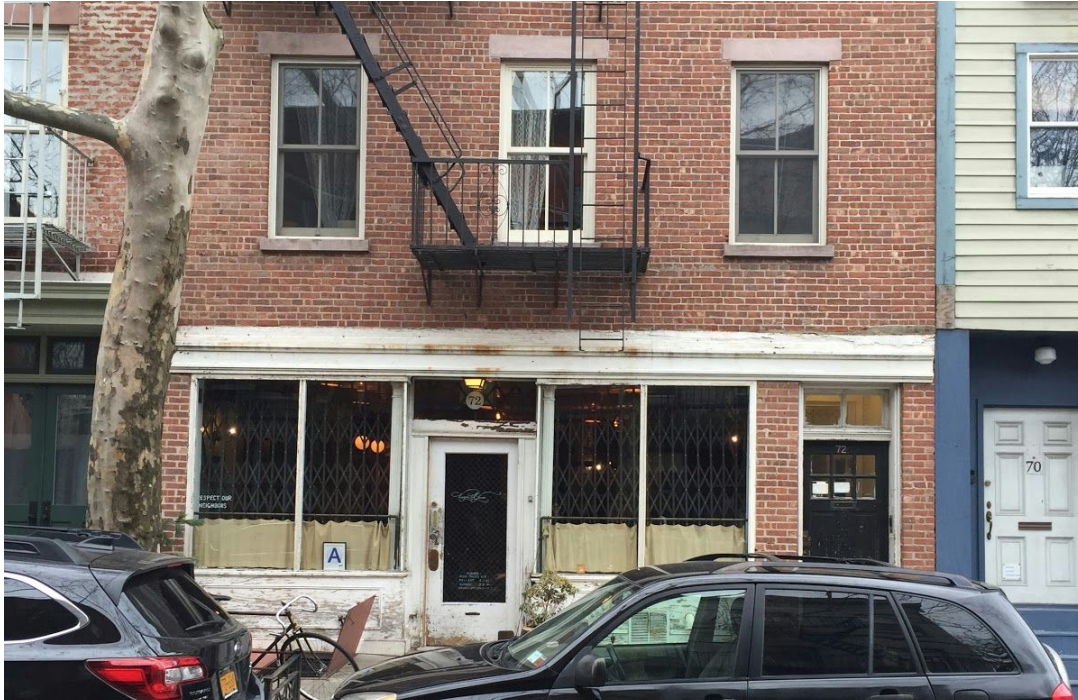
This is a Three story building located at 72 Hudson Ave. The commercial space is on the ground floor, while residential spaces are located on the above floors. The building has a common bond brick pattern with wooden Bulkheads and display windows, as well as a decorative cornice. To the right of this building is 70 Hudson Ave., which has a wooden framed architecture with wooden siding. This wooden architecture style indicates that this building may date back to the 1830s.

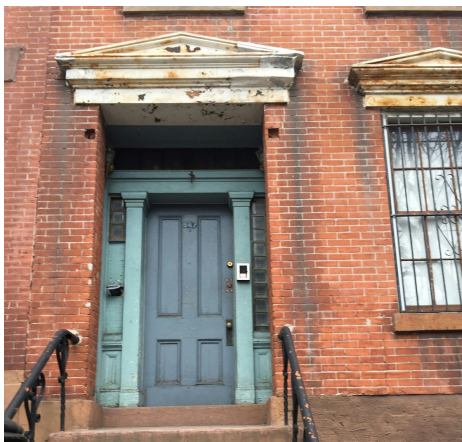
Located on front street between Gold st. and Bridge st. This home appears to be dated between 1830 - 1850 based on the Greek revival Styles. There is rust on the cornice and window moldings. There is a mix of brownstone and brick facade. There is a high stoop with classical design patterns on the door.

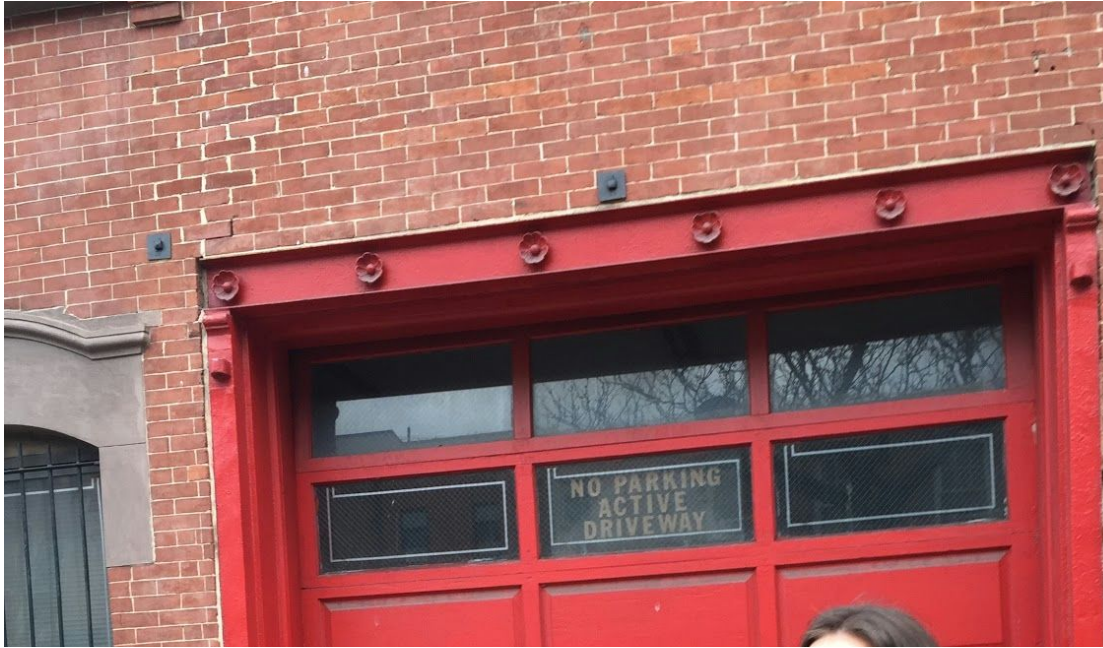
This image depicts an old fire station that has been renovated into a residential living space.

The fire station at 227 Front St. has a unique design similar to an Italianate architecture style. It is three stories with rounded arched windows and brownstone sills. The cornice is bracketed and has

recessed panels with an arched fascia. The building should date back to around the 1840s and 1870s.

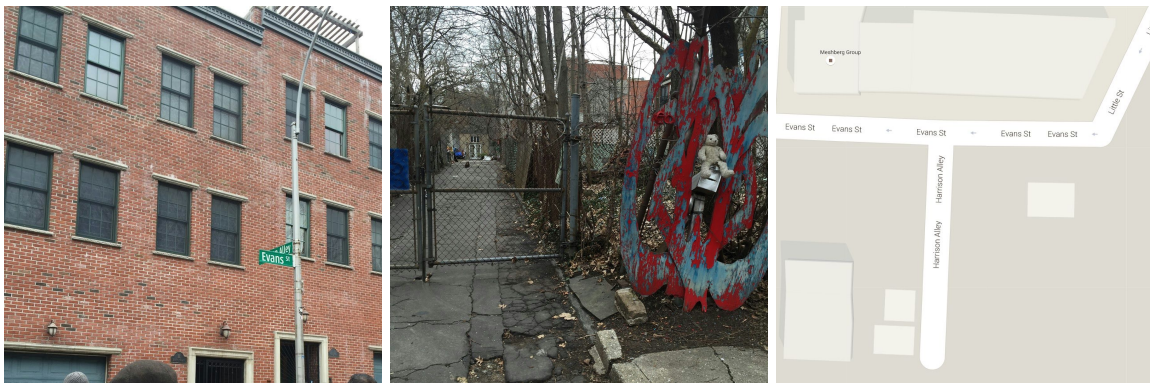
In the first image you can see a more recently developed residential building 13 Evans Street. This building has indoor garages and is three stories tall. The building may have replaced a former alley. A street sign is visible pointing in the direction of the waterfront, indicating this alley once had a longer stretch. In the second image we see this alley is fenced off and no longer in use.
